Home Inspection Report

4826 Lake Harbor Dr., Houston, TX 77063

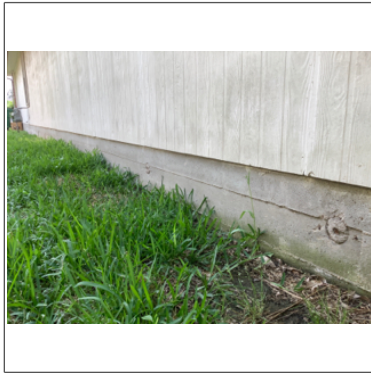
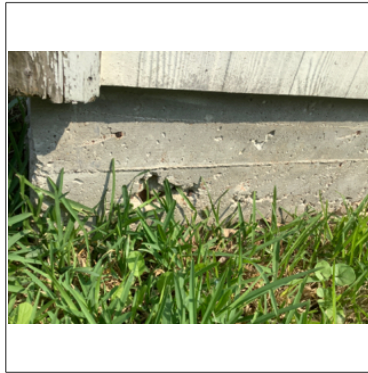
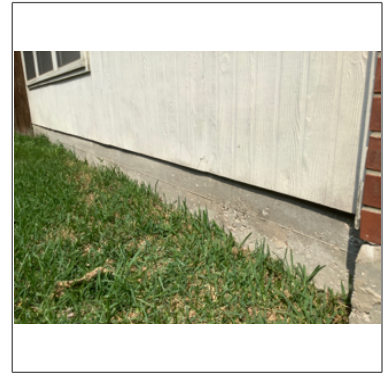
B. Grading and Drainage

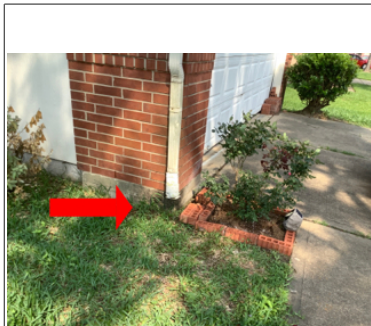
Elbow to downspout should be attached and extend far enough out to adequately divert water away from foundation. In addition a splash block should be installed to route water to a drain.

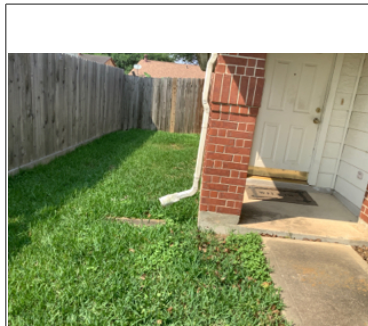
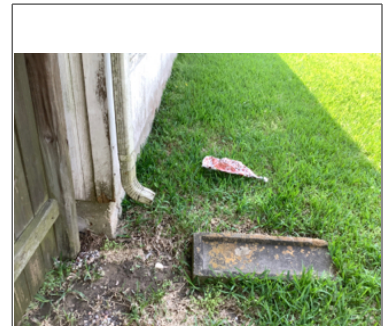
Downspout is not securely attached to structure, and splash block should be repositioned to catch water and drain properly.

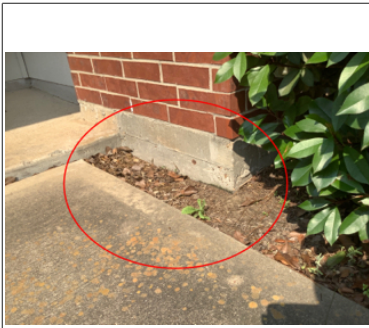
This could potentially be an area where water could pool and begin to affect the performance of the foundation. It is recommended to fill the grade to slope away from the house or fill in with concrete.

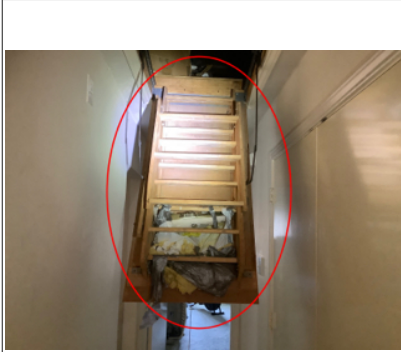
Attic access door insulation is not adequate. It is recommended that access door is weatherstripped with a tight seal and door is insulated throughout to prevent conditioned air from escaping home into attic.

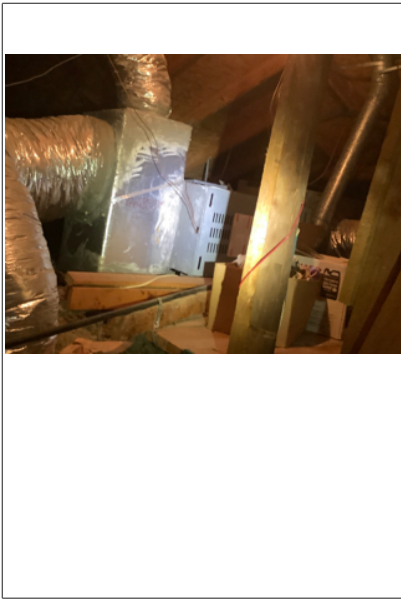
E. Walls (Interior and Exterior)

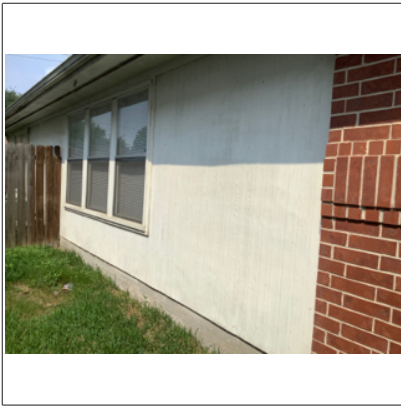
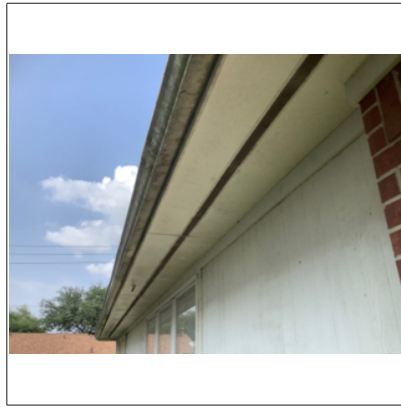
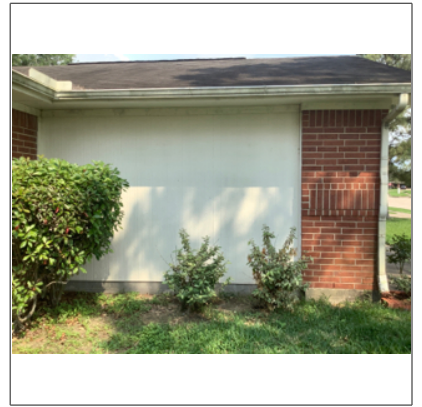
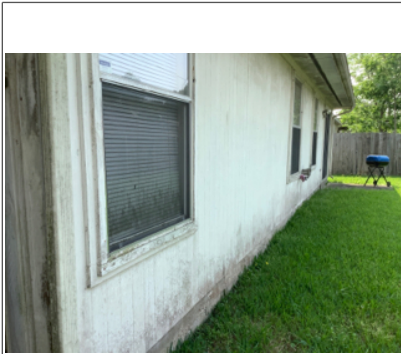
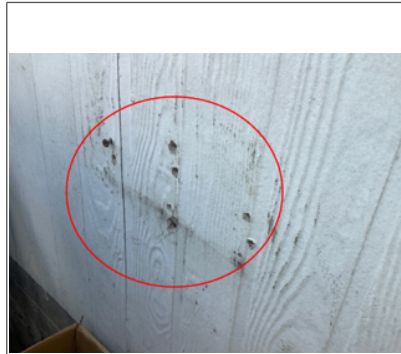
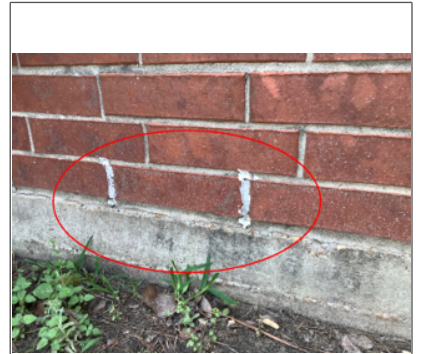
There are some screw hole penetrations through the wood siding that could allow water to penetrate to the wood structure behind the siding that could promote decay. It is recommended that these holes are patched and sealed up.

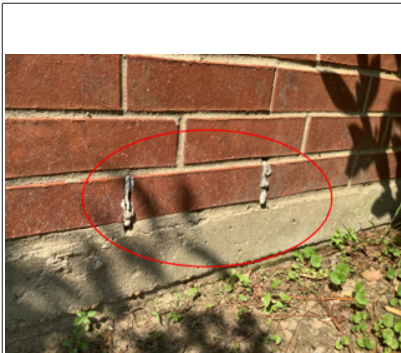
Improperly caulked weep holes

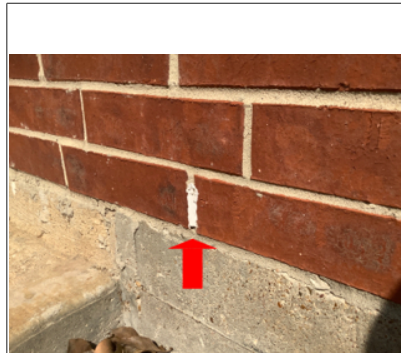
Improperly caulked weep hole

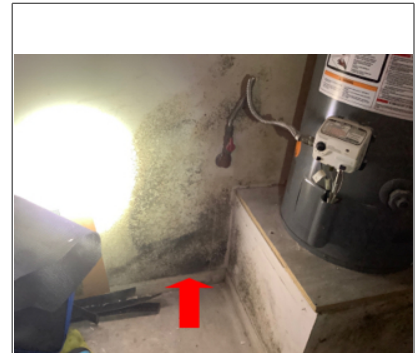
Organic mold-like substance found on garage wall near hot water heater. It's possible this could be from previous plumbing pipe damage behind wall or a current leak situation. I recommend evaluation by a specialist.

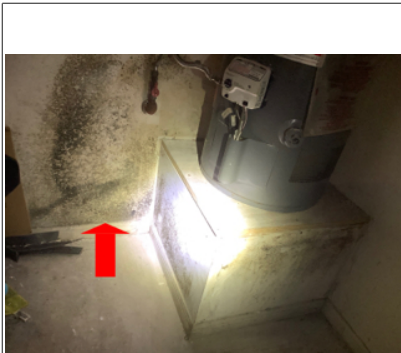
Organic mold-like substance found on garage wall near hot water heater. It's possible this could be from previous plumbing pipe damage behind wall or a current leak situation. I recommend evaluation by a specialist.

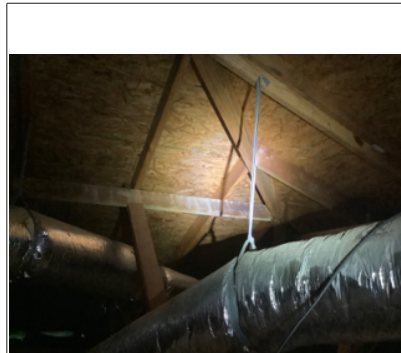
F. Ceilings and Floors

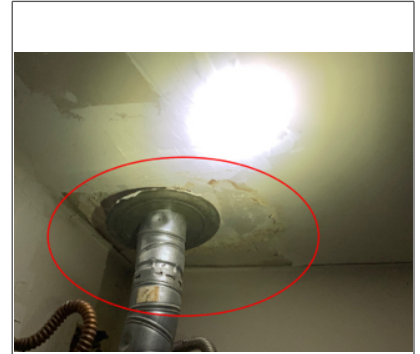
Drywall around hot water heater vent pipe termination is not sealed tightly. This area should be properly sealed to allow flue gases to vent safely without leaking to attic, garage or any living spaces throughout the home.

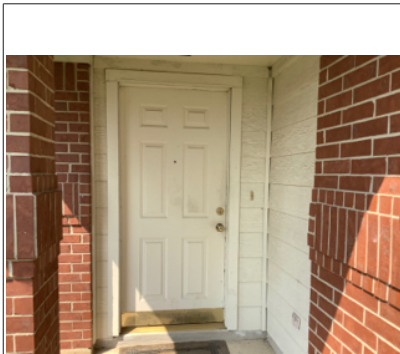
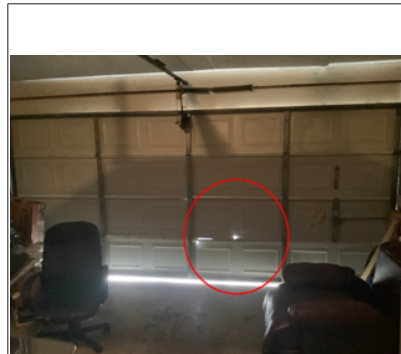
Steel garage door panel has holes in it. In most instances the holes cannot be repaired, however the entire panel would have to be replaced.

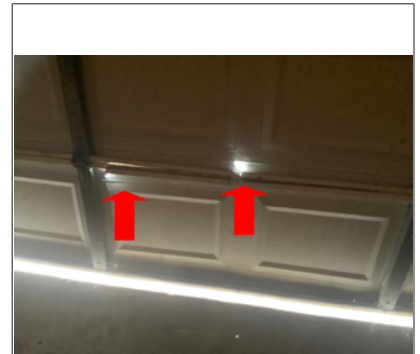
Steel garage door panel has holes in it. In most instances the holes cannot be repaired, however the entire panel would have to be replaced. 2 panels show damage.

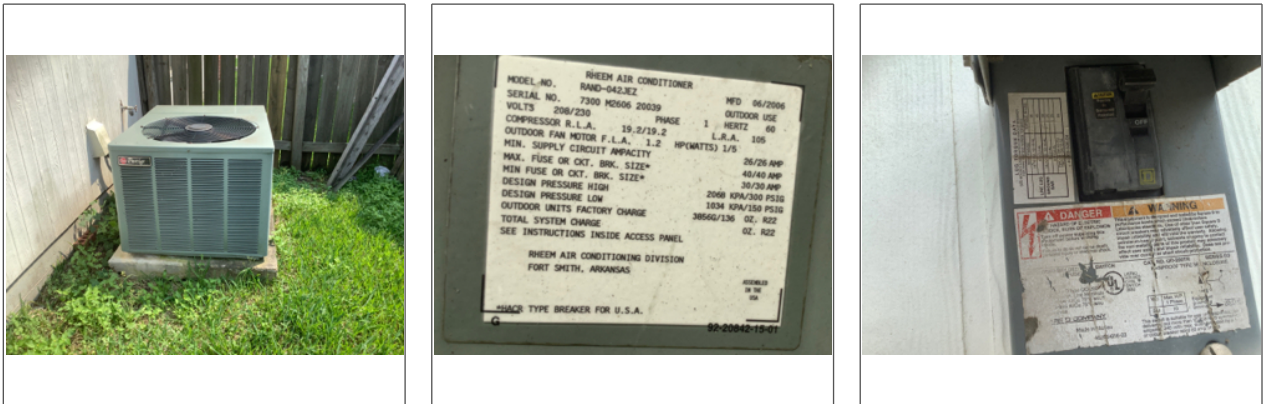
III. HEATING, VENTILATION AND AIR CONDITIONING SYSTEMS PHOTOS

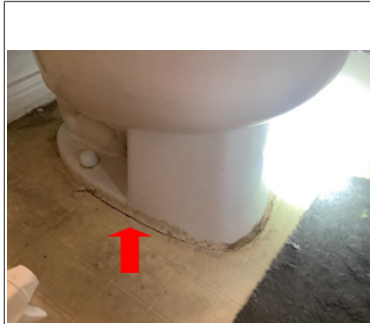
Commode base loose and needs proper caulking/sealant.

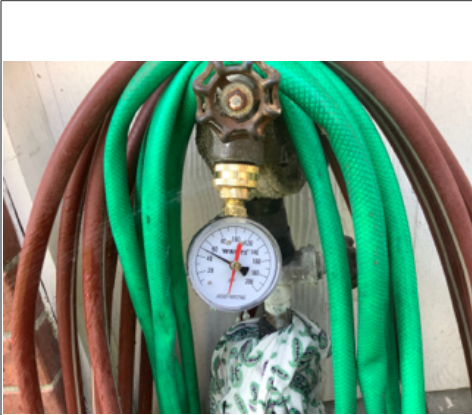
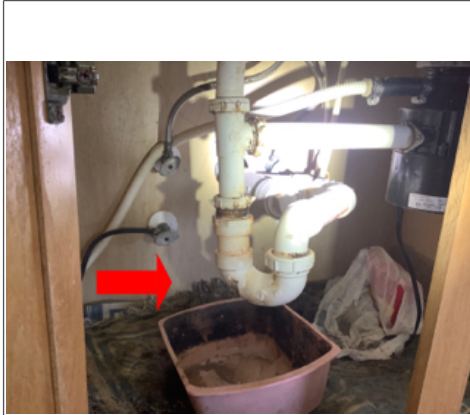
P trap and piping underneath kitchen sink appears to be leaking. The floorboard underneath the sink is rotted and damaged and here is a bucket to catch water underneath pipes. I recommend examination and repair by a licensed plumber.

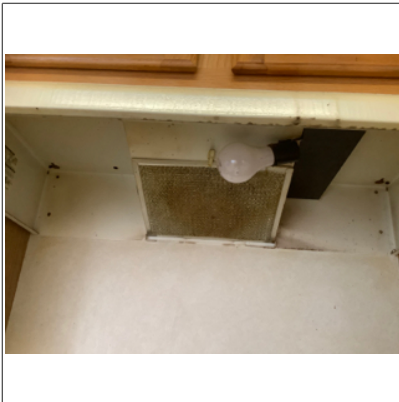
G. Garage Door Operators

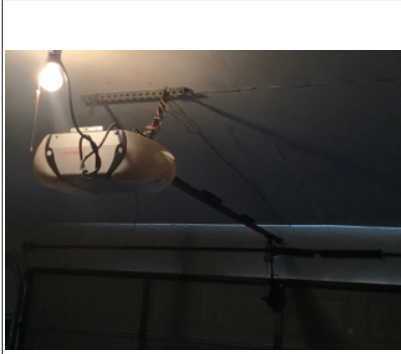
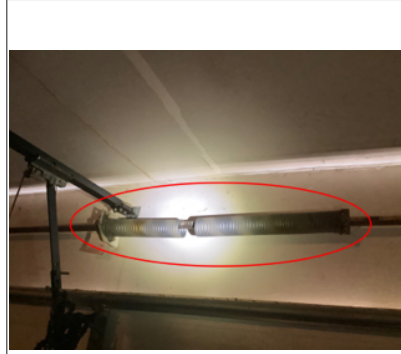
Garage door spring is broken. I recommend repair by a specialist.

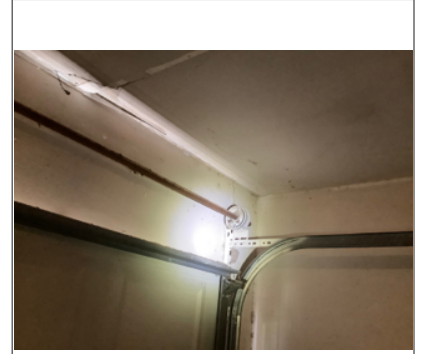
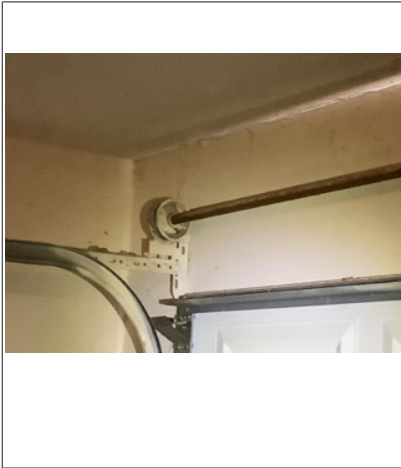
H. Dryer Exhaust Systems
